RISK ASSESSMENT

CBE 9185 Project

BHOPAL DISASTER CASE STUDY

Dawood Al-Mosuli

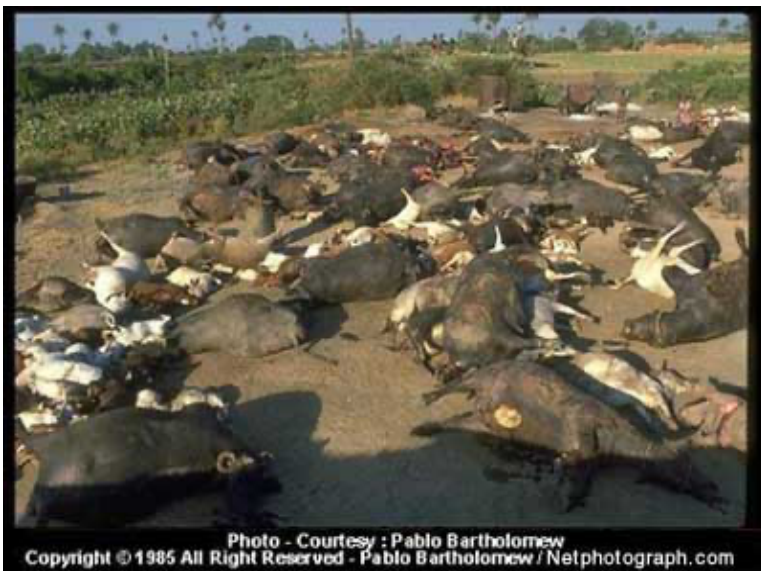
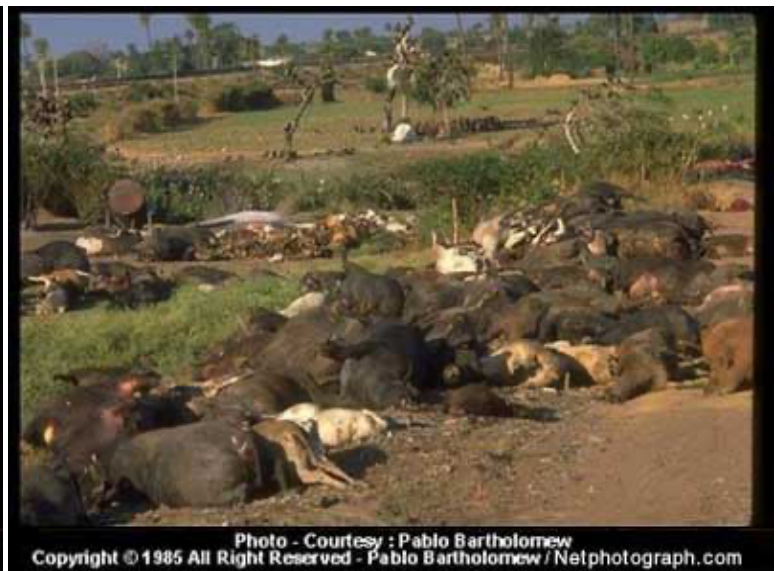
Figure(7)effects of Inhaling MIC

- Effects at 0.4ppm
 - Breathlessness
 - Choking
 - Asthma
 - Throat Irritation
 - Eye Irritation
 - Skin Damage
 - Vomiting
 - Muscular Weakness
 - Altered Consciousness
- Effects at 21ppm
 - Pulmonary Edema
 - Emphysema
 - Hemorrhages
 - Bronchial Pneumonia
 - Death
